ROOF HAIL DAMAGE ASSESSMENT

Project: Brant Medical Clinic
6801 NW 39th Expressway
Bethany, OK 73008

Date of Loss: 5/16/10
File # 214.443

Date of Site Visit: 9/11/12
Time of Visit: 9:30 a.m.

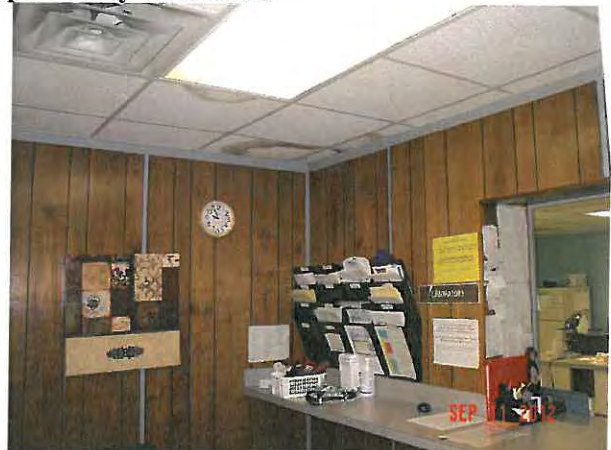
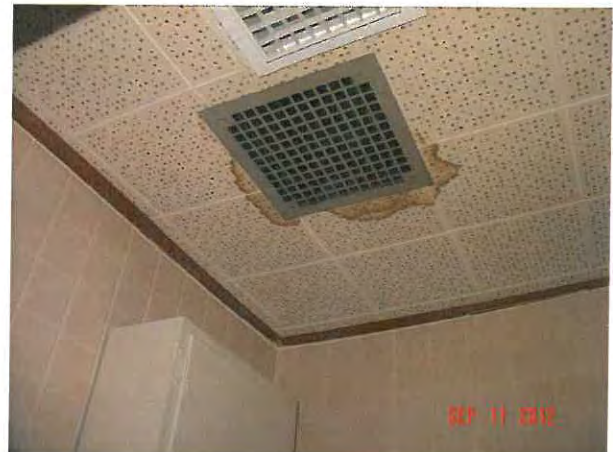
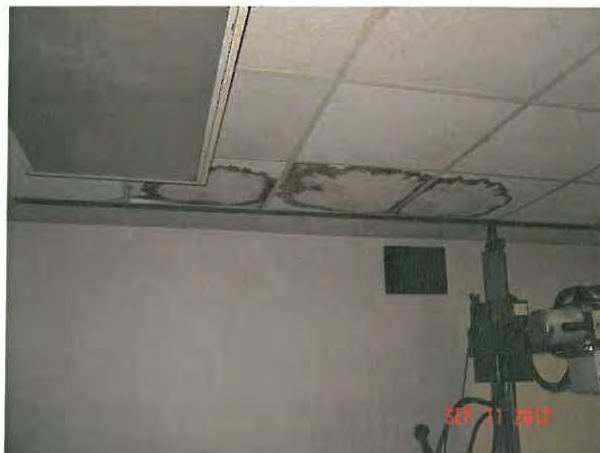
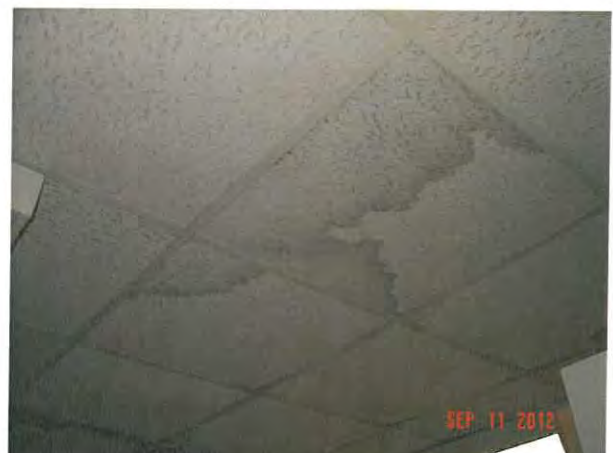
Typical interior leaks reported by Dr. Brant

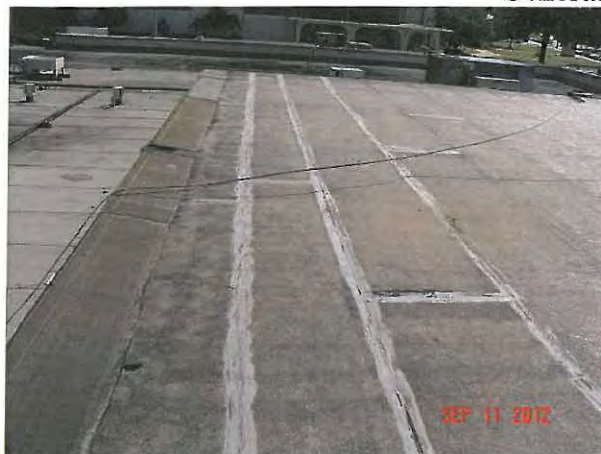
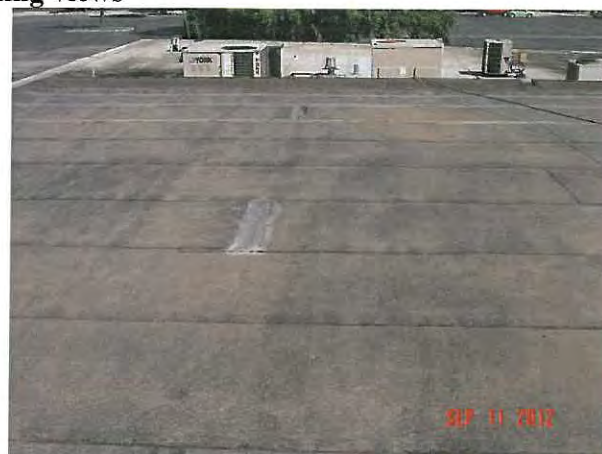
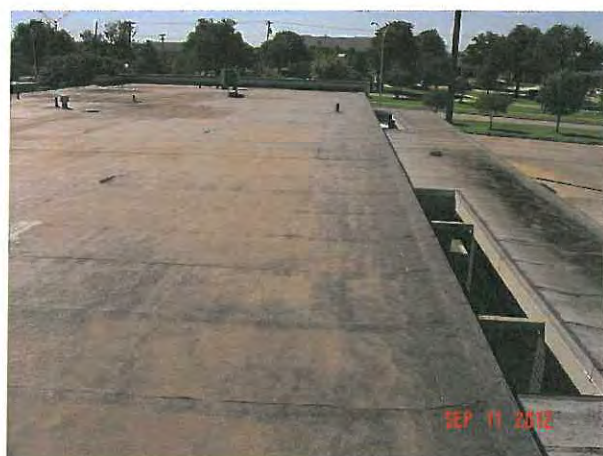
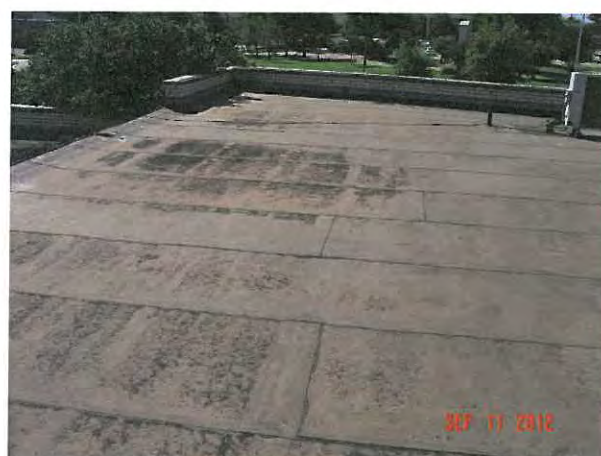
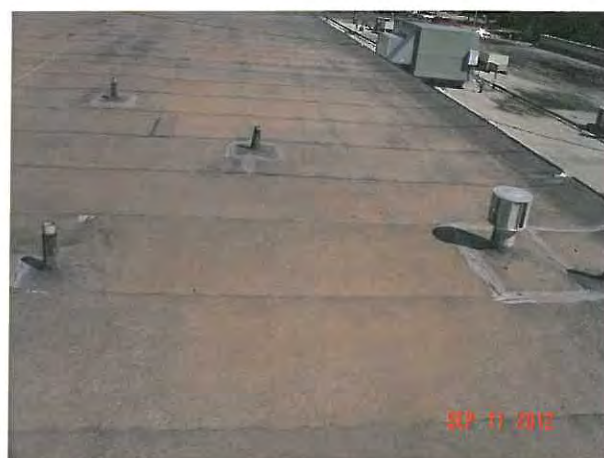
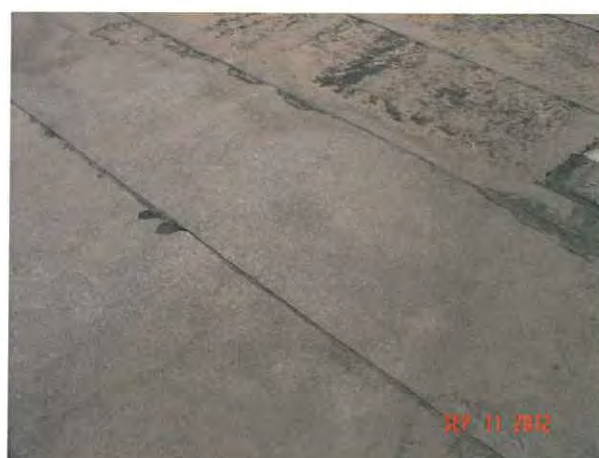
ROOF AREA 1

General roofing views

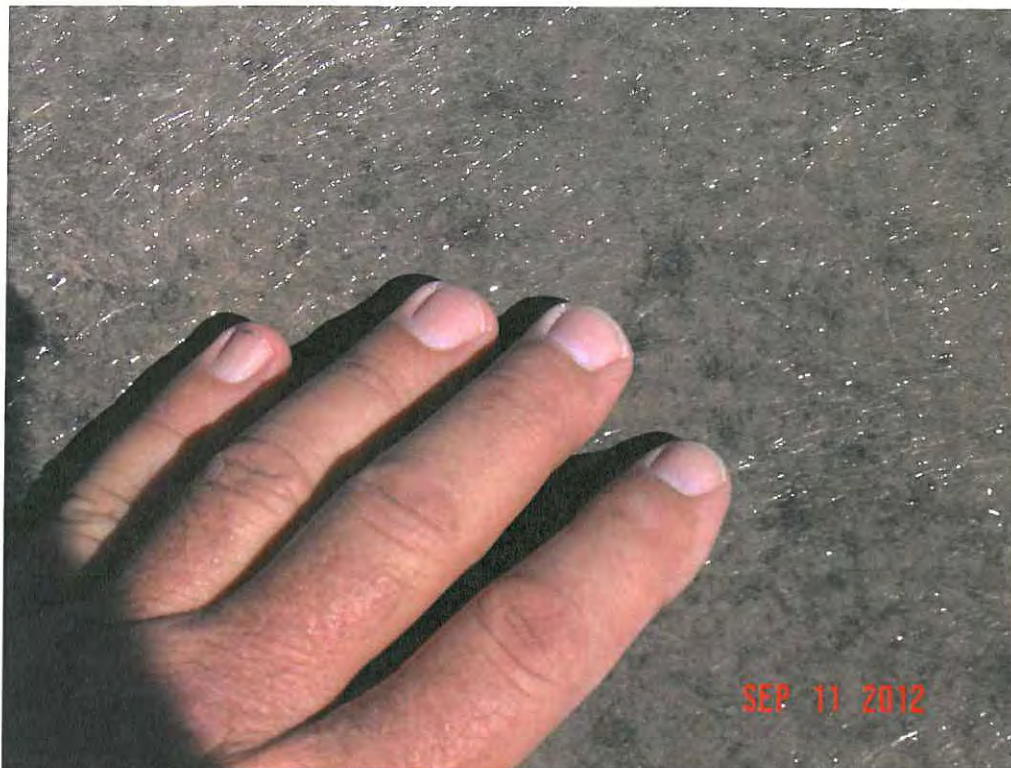
Dirt has accumulated in the ponded areas and remains deposited on the roof surface. There are also small (pea to dime sized) visible splatter marks in the dirt that has accumulated on the surface of the roof where possible hail strikes have dislodged the dirt exposing the membrane below. I made a hands and knees examination of these splatter marks and find no evidence whatsoever of any hail damage to the roofing membrane.

Small hail splatter marks in the dirt accumulation on the roof

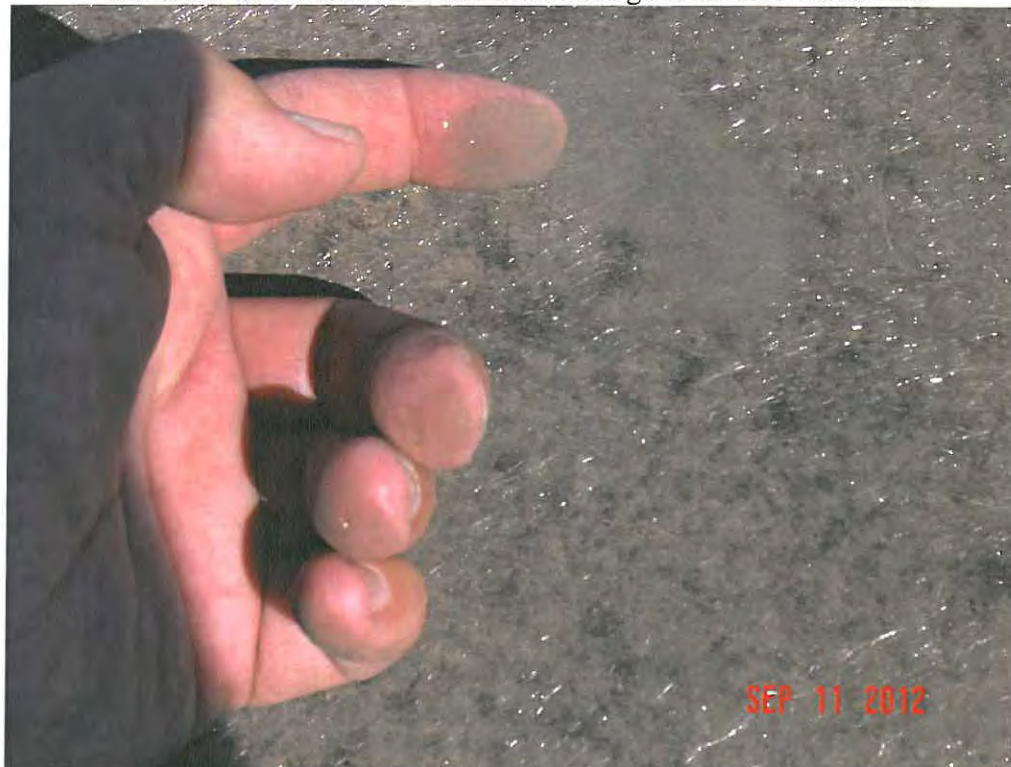
The splatter marks are displaced dirt only
When the dirt is removed there is no damage to the roof membrane

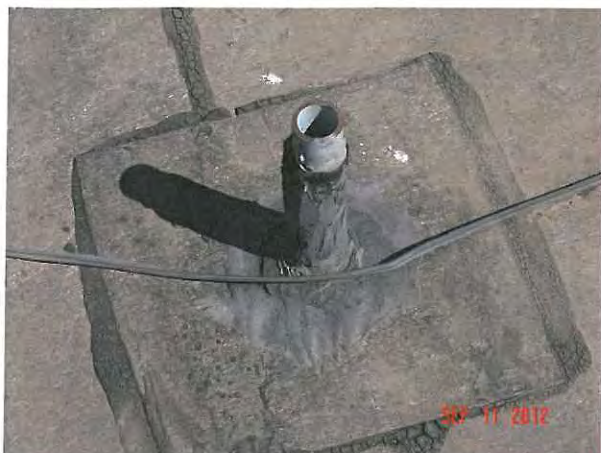
Improper detailing, leak potential

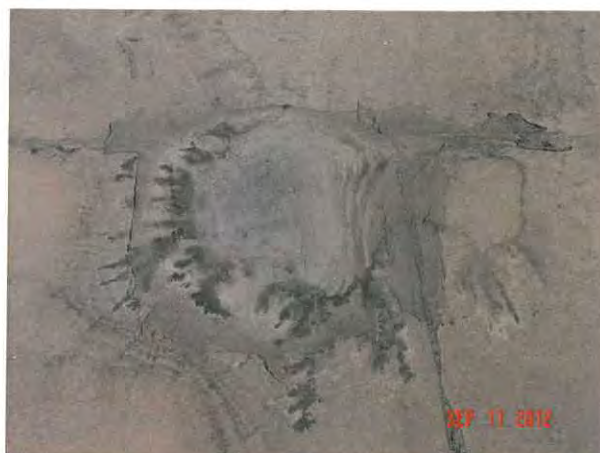
Improper repair, leak potential

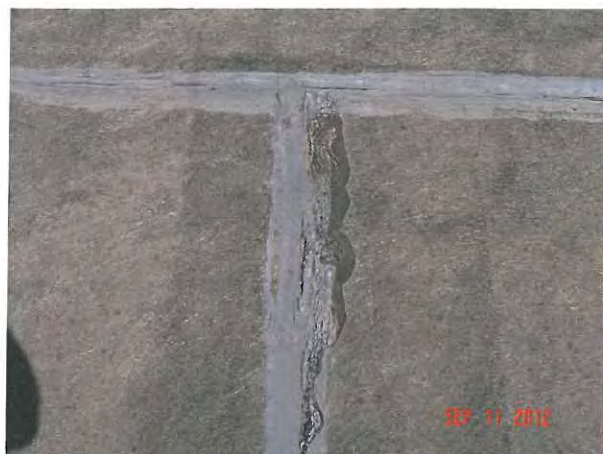
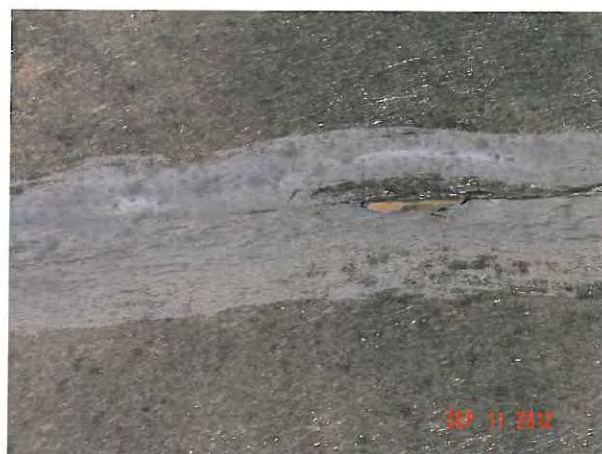
Failed repairs, leak potential

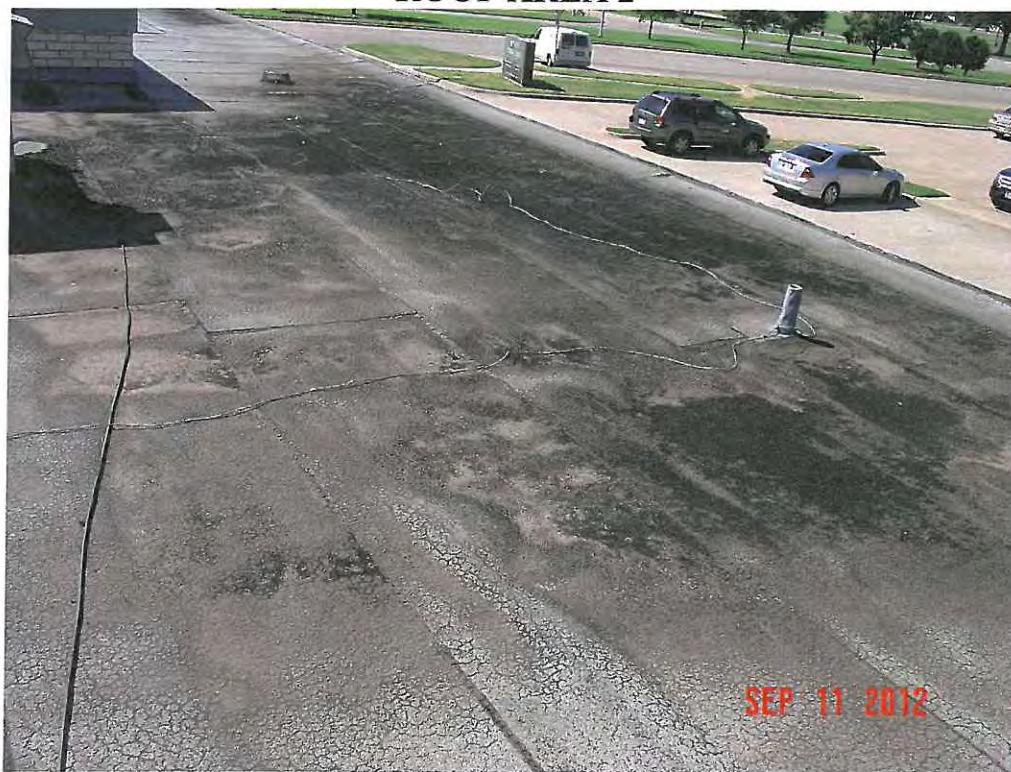
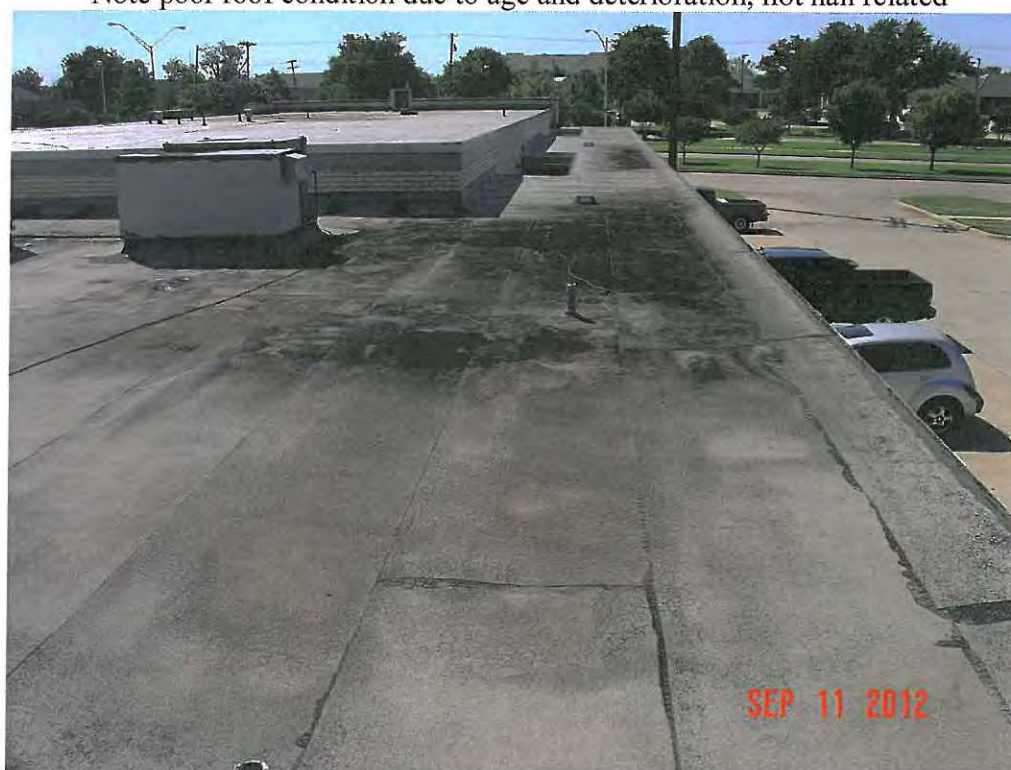
Note poor roof condition due to age and deterioration, not hail related

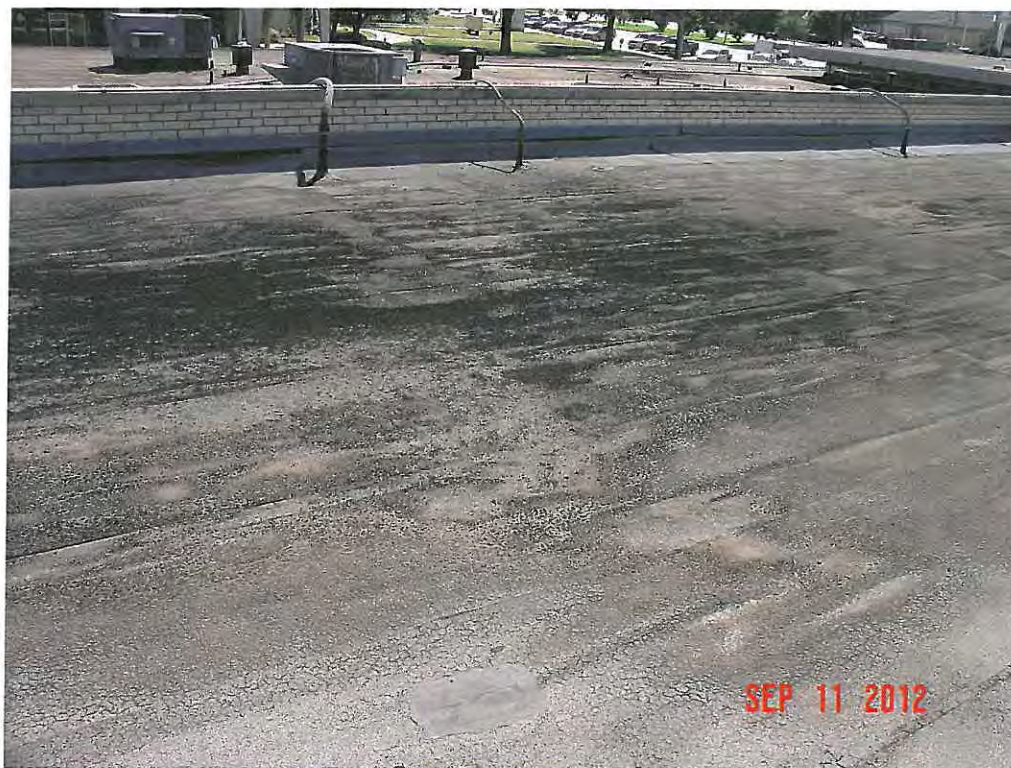
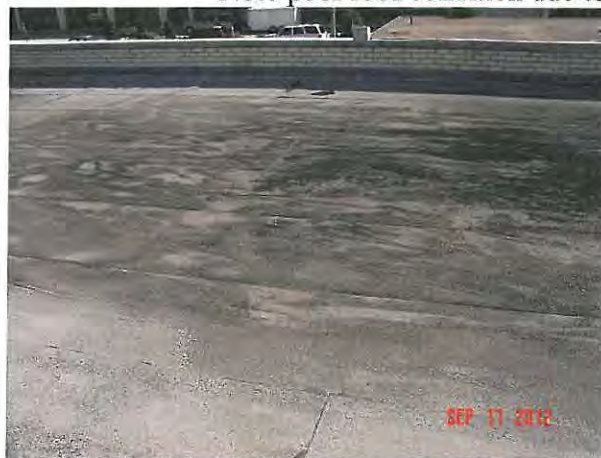
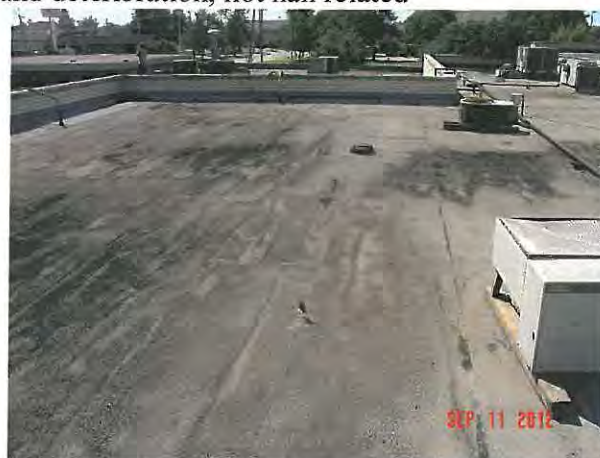
The granular loss and mud cracking typically occurs at the blistered and ponding areas making these defects obvious products of heat aging and deterioration. There is absolutely no pattern of granular loss on the roof that would be consistent with hail strikes. I carefully examined the areas where the granular loss has occurred for any hail damage to the roofing membrane and found none. Granular loss is a function of age and deterioration and in this instance is not the result of any hail storm. The most severe granular loss in this entire roof area occurs at the areas of the most severe ponding water.

Note poor roof condition due to age and deterioration, not hail related

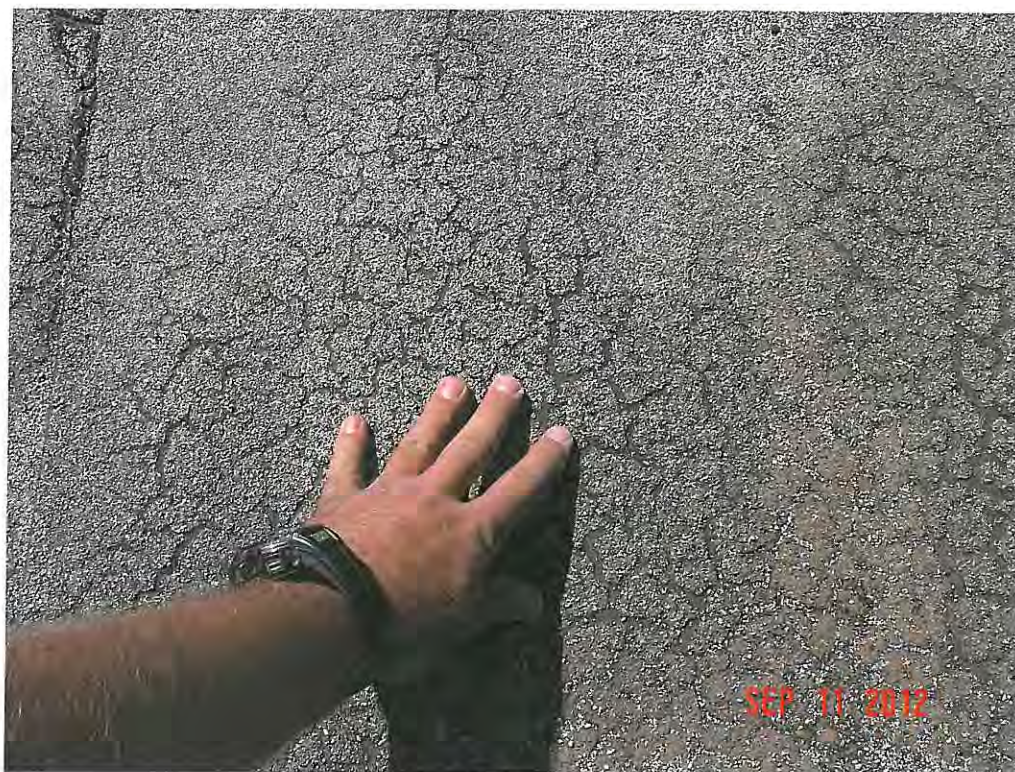
Alligatored surfacing, not hail related

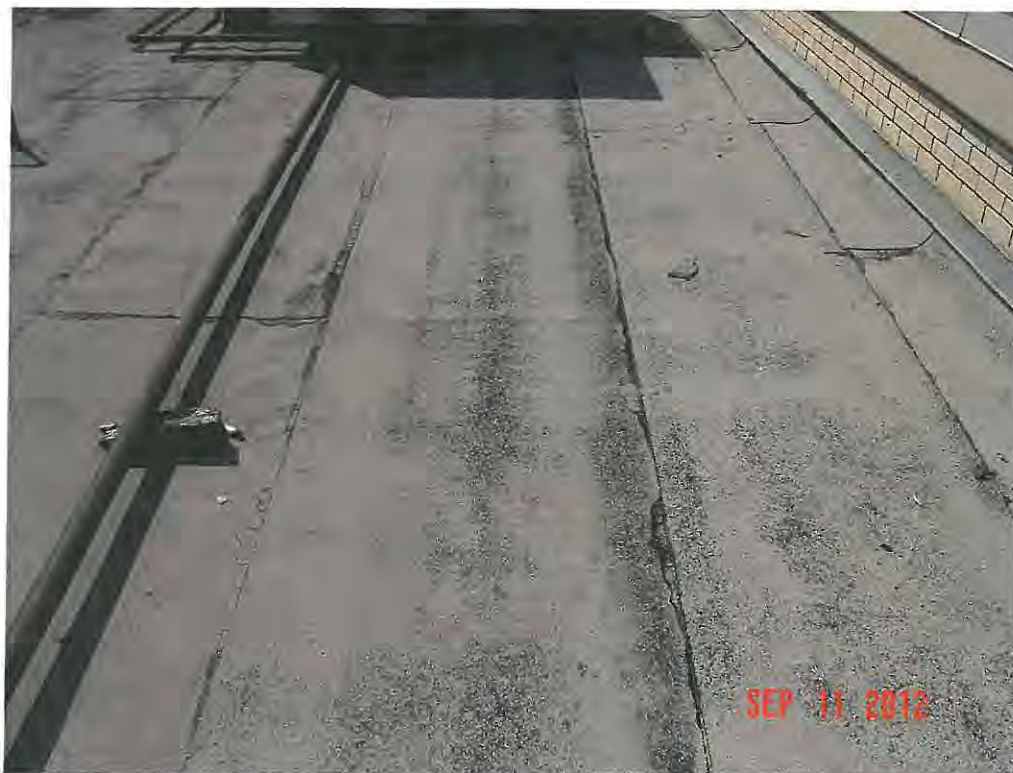
Granule loss due to age and deterioration, not hail related

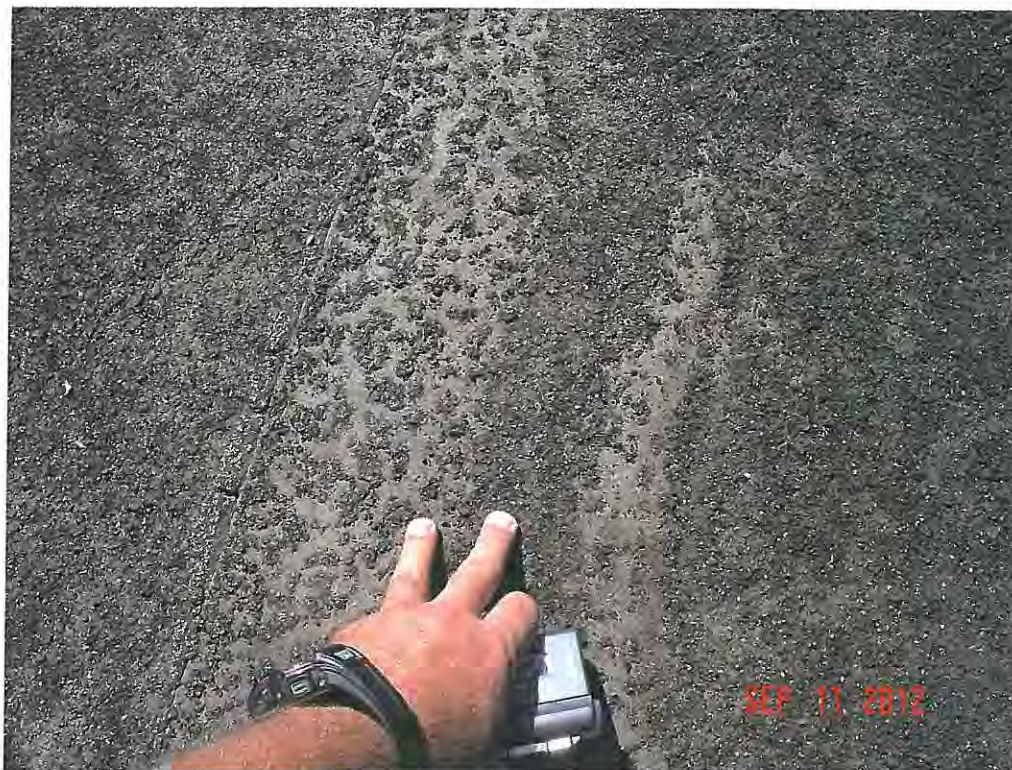
Granule loss due to age and deterioration, not hail related

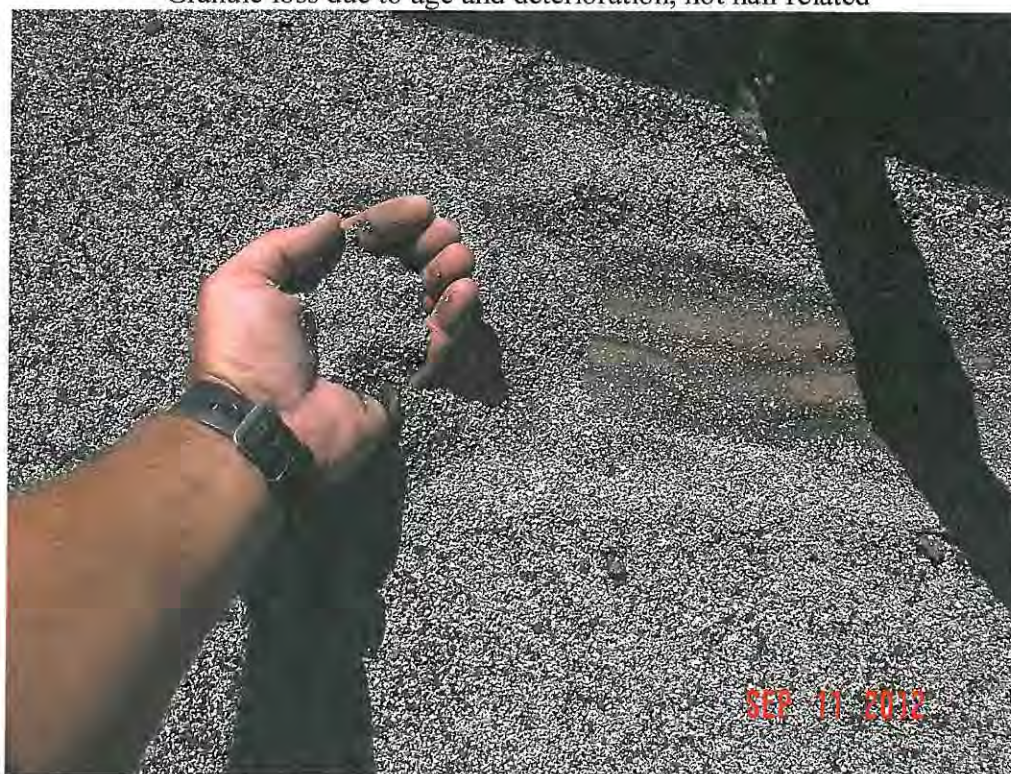
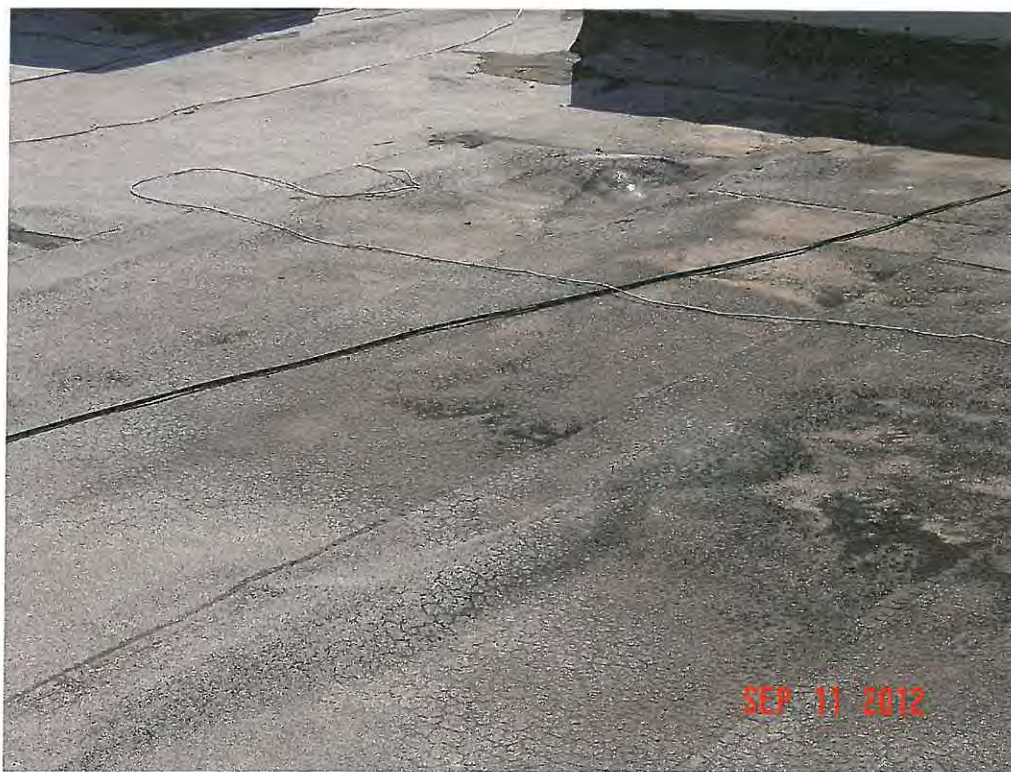
Blistering and alligatoring, not hail related

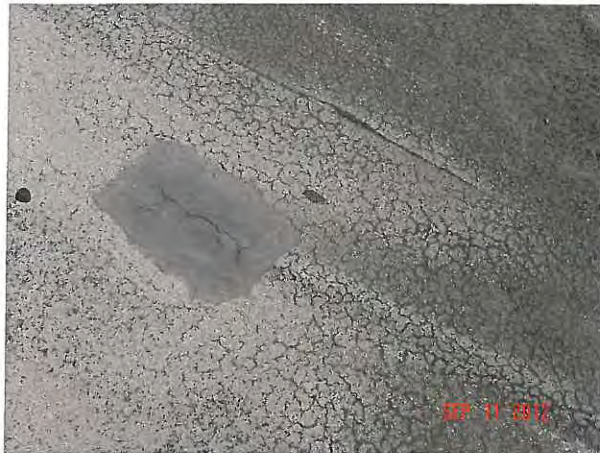
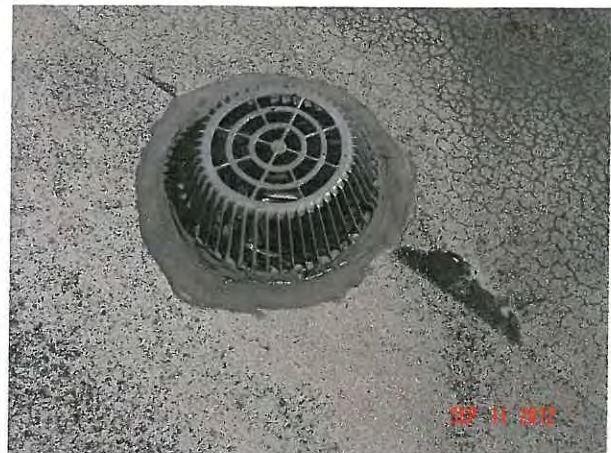
Improper repairs, leak potential

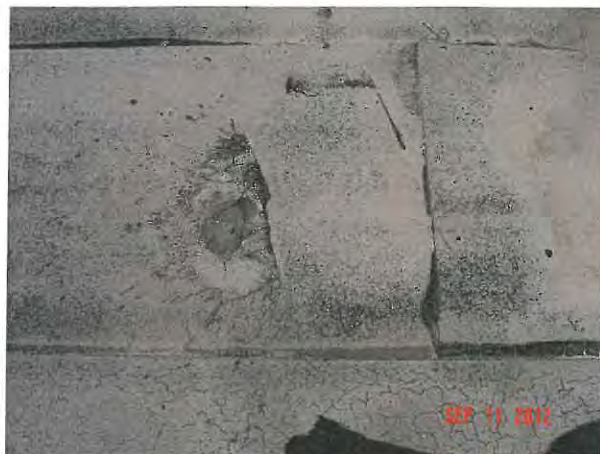
Improper repair, leak potential

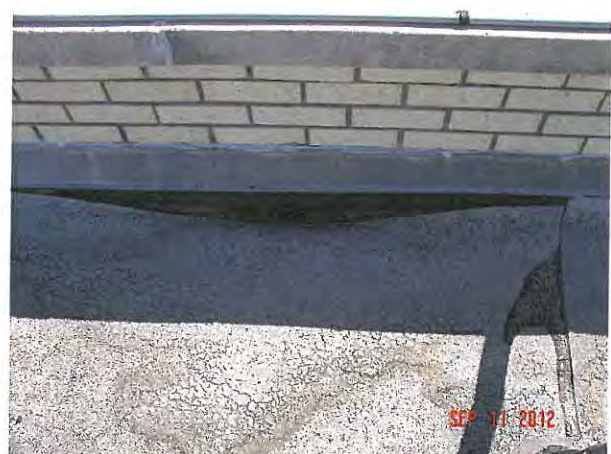
Open flashing, leak potential

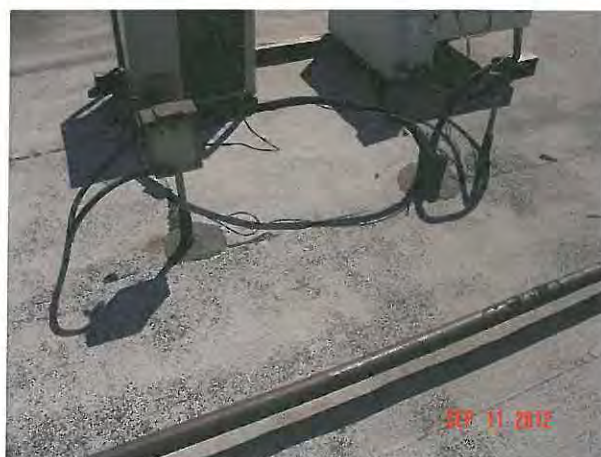
Improper detailing, leak potential

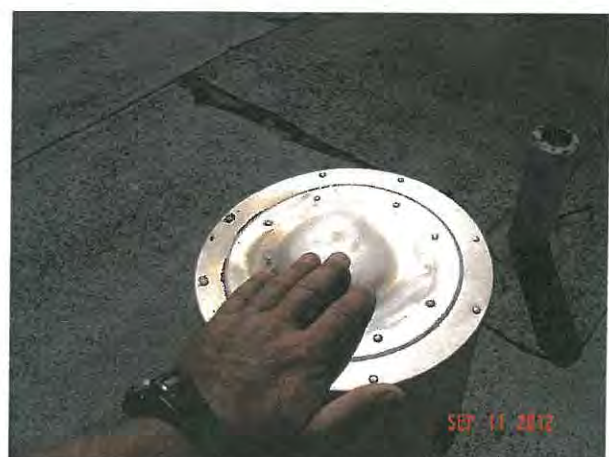
There is no hail damage to any of the membrane roofing assemblies on the subject building. Small hail dings on the aluminum vent caps are esthetic only and do not effect the performance of the caps. The caps can be replaced at a cost in the range of \$25-75/each. Damages to the coil fins of the roof mounted condensing units caused by the subject hail storm are minor and can be corrected by combing the fins.

Small hail dings on soft aluminum cap

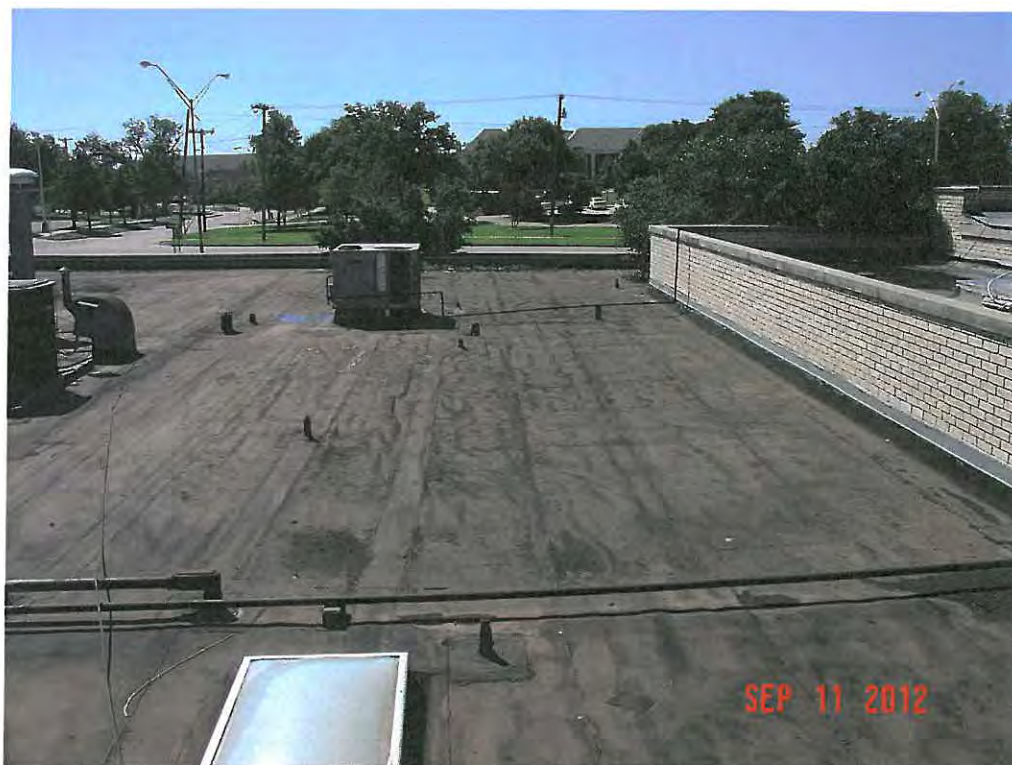
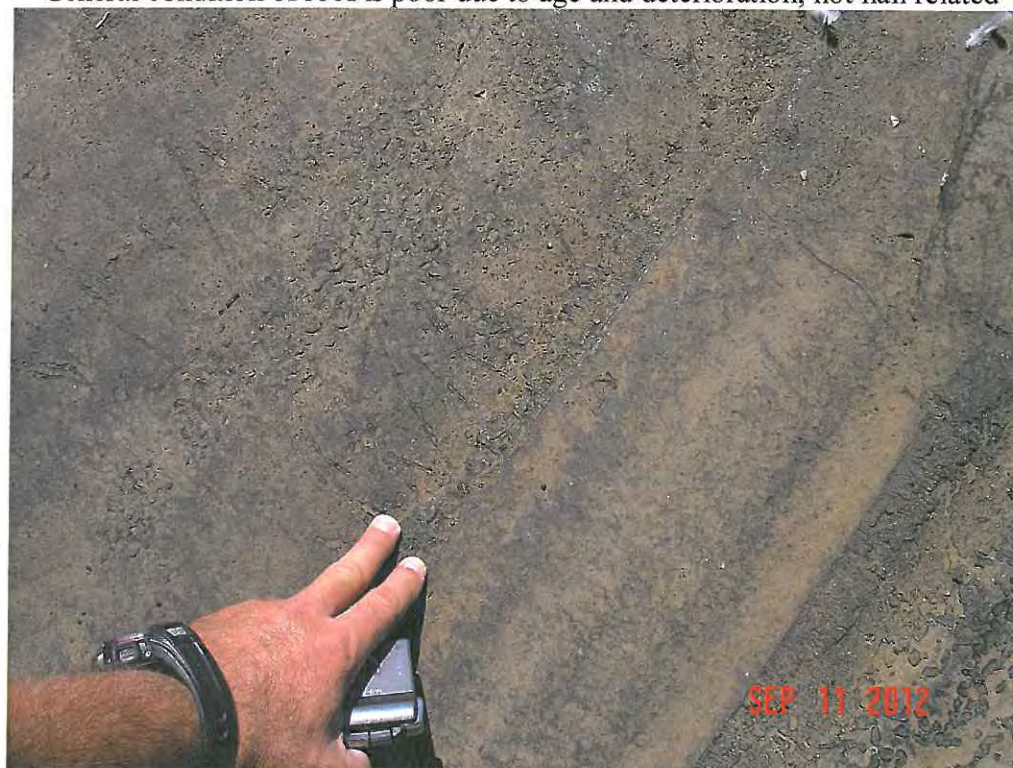
General condition of roof is poor due to age and deterioration, not hail related

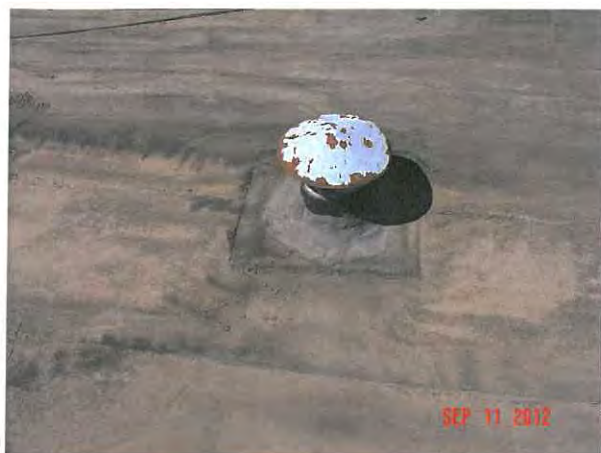
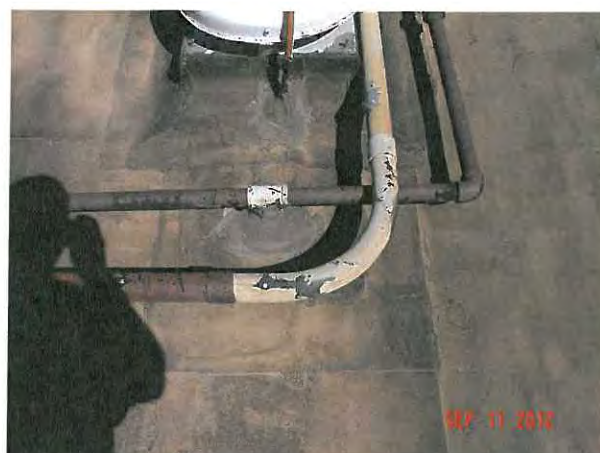
Improper detailing creates leak potential

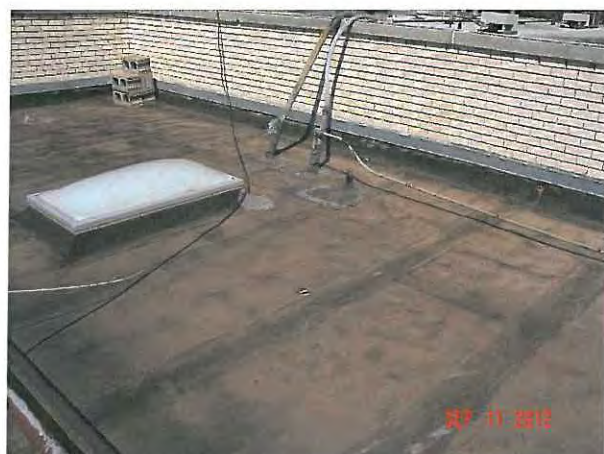
Improper detailing creates leak potential

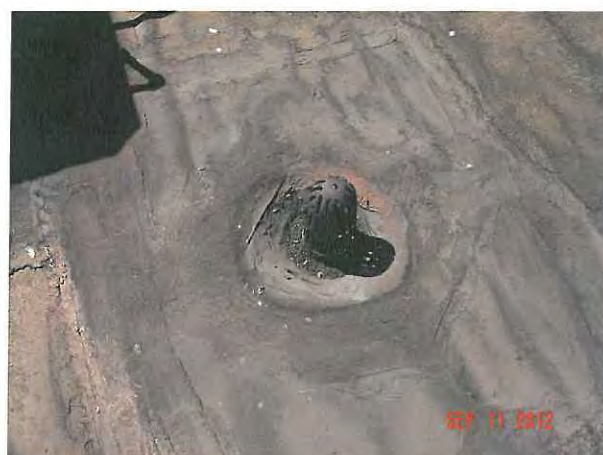
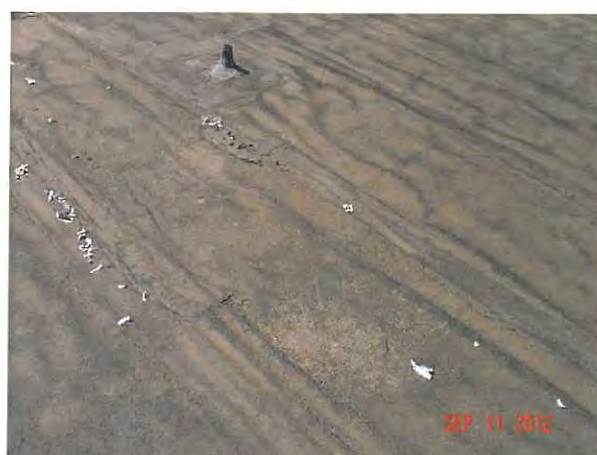
Improper repairs create leak potential

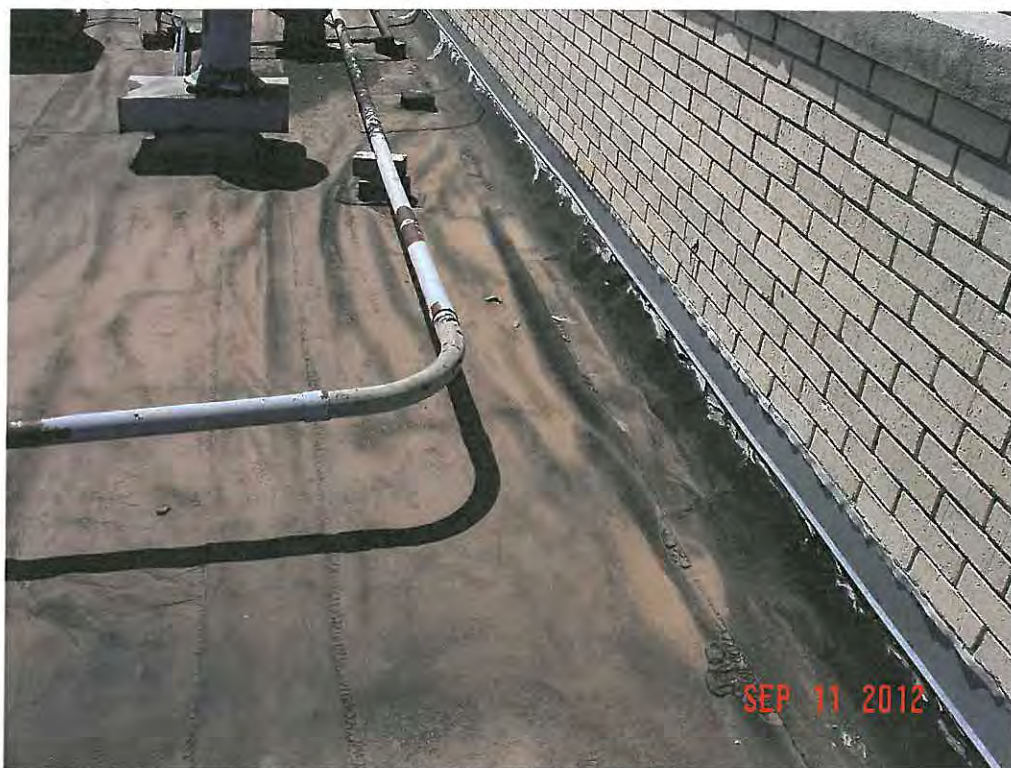
Open base flashing at wall creates leak potential

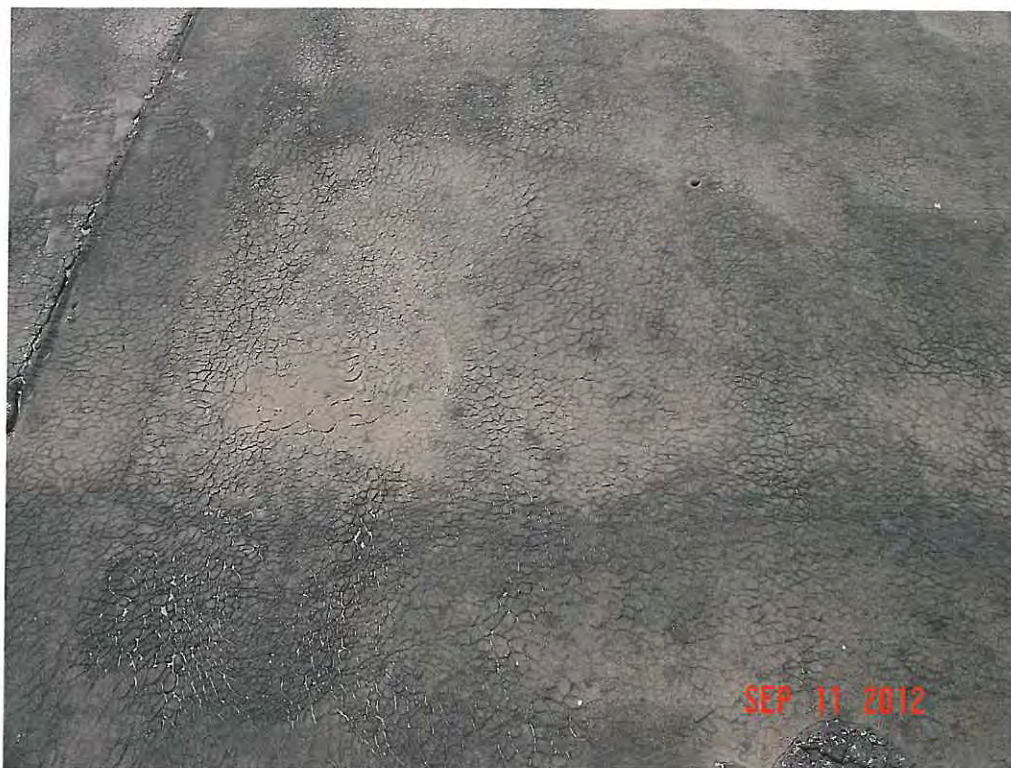
The splatter marks are displaced dirt only
When the dirt is removed there is no damage to the roof membrane

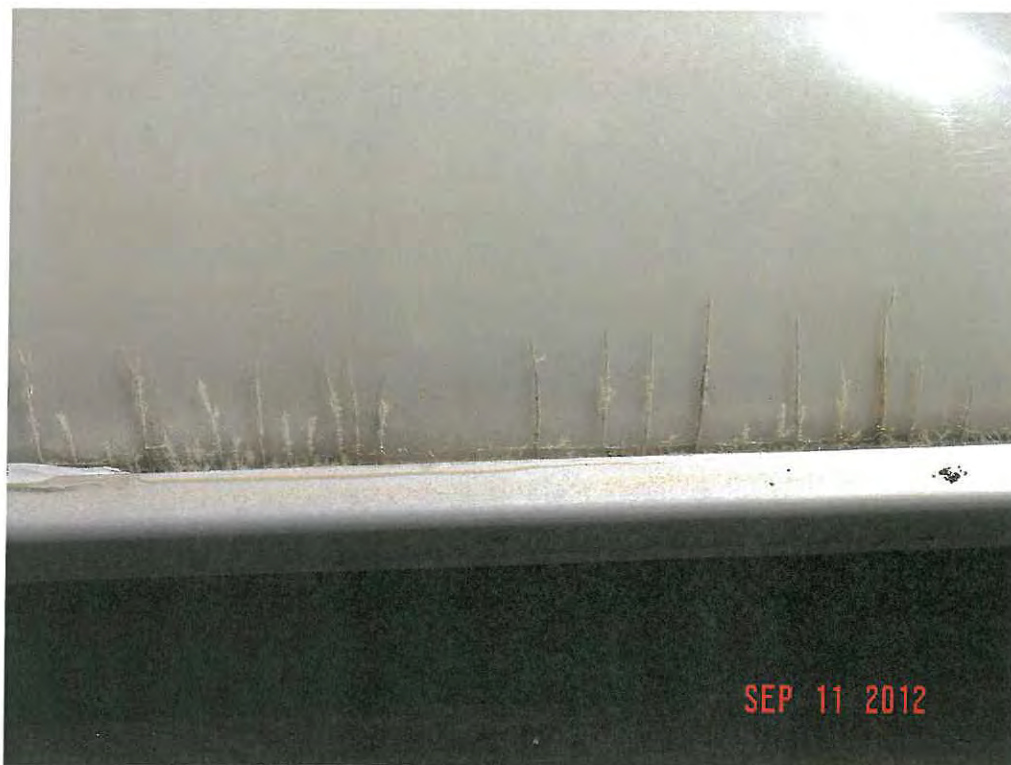
One acrylic skylight is located in this roof area. The skylight is very aged and dry as evidenced by stress cracking from the edges of the skylight. These skylights typically become very brittle with age and are most susceptible to hail damage. There is no hail damage to this skylight.

Skylight has lost plasticizers and has become very fragile
as evidenced by stress cracks

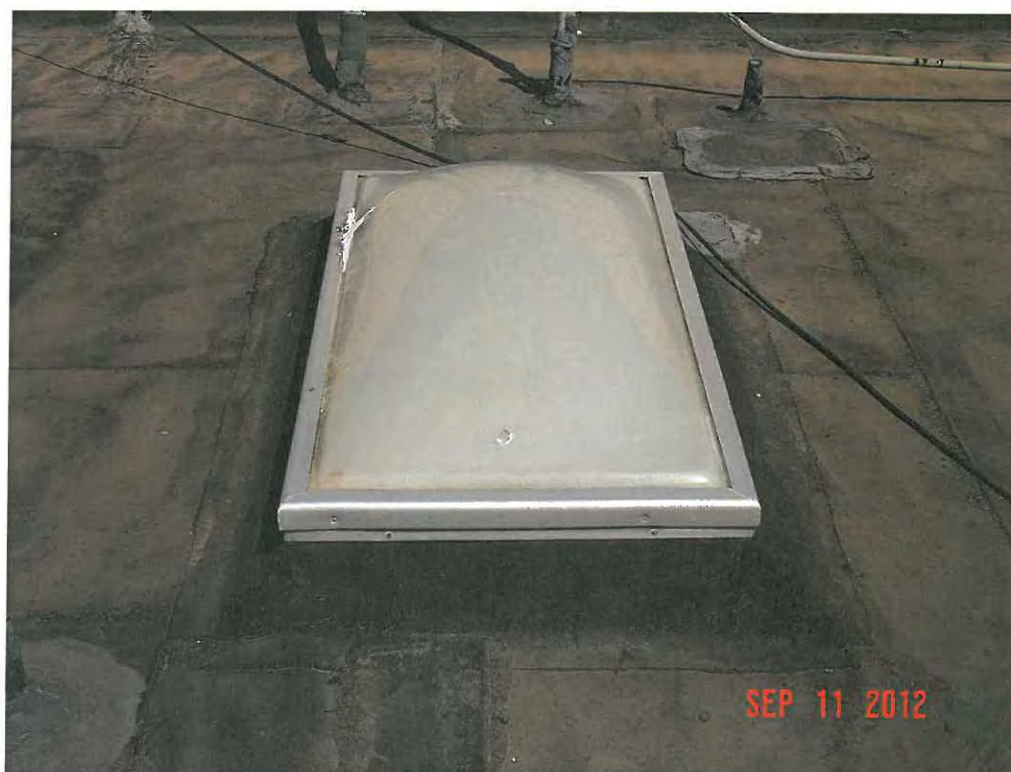
No hail damage to fragile skylight

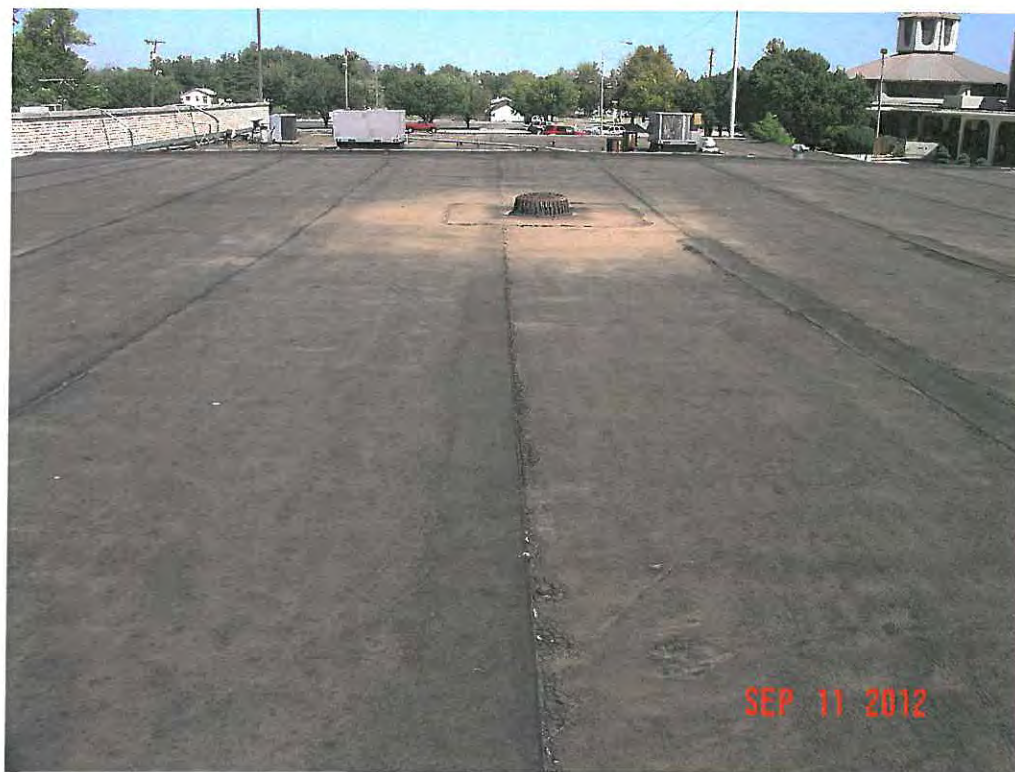
ROOF AREA 4

Age and condition same as roof area 3

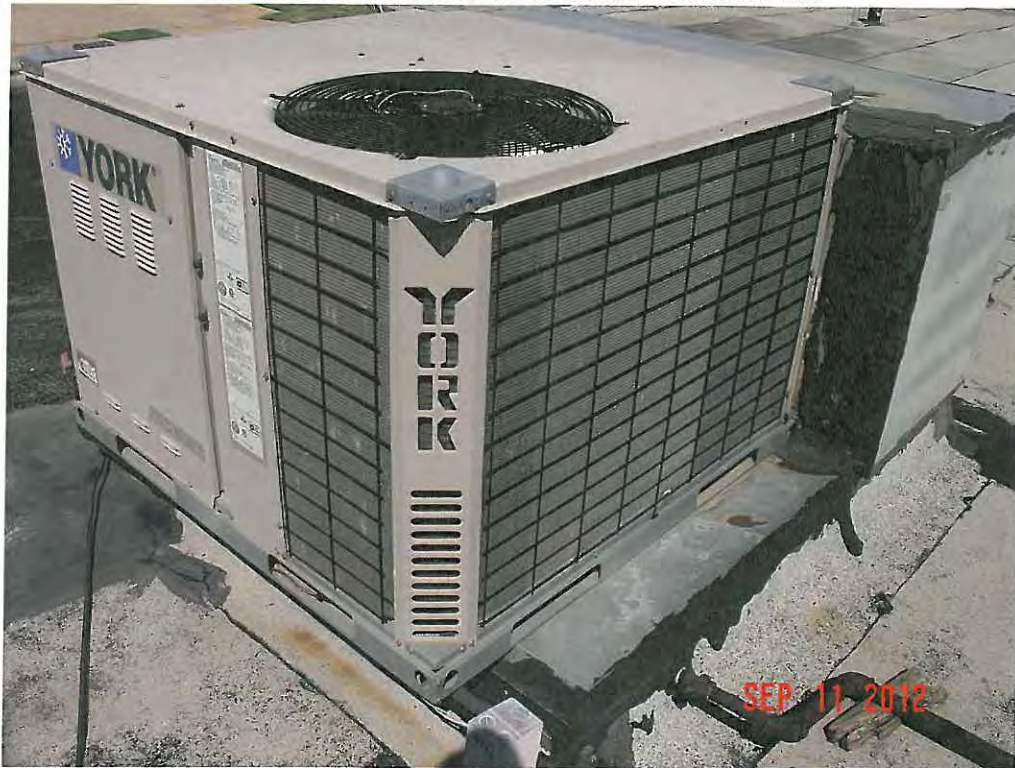
Newer units display very little coil fin damage
This is an indication that the subject hail storm produced only very small hail
